**Release Abatement Measure
Completion Report
Former Nu-Style Facility – 87 Grove Street
RTN 2-16694**

Town of Franklin, Massachusetts

April 2013

**Site Photographs
Former NuStyle Facility
Franklin, Massachusetts
Taken March 2012 – March 2013**

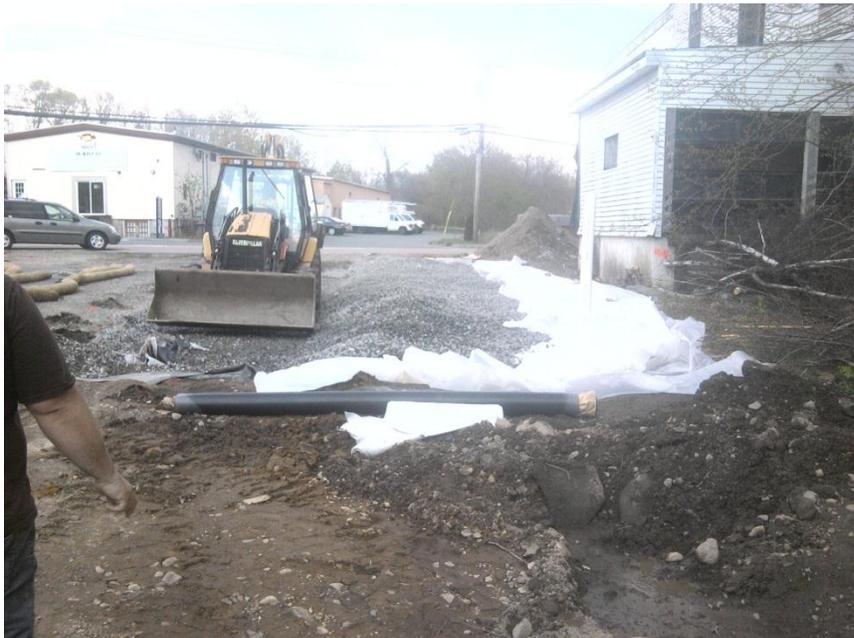
Truck wash pad installation

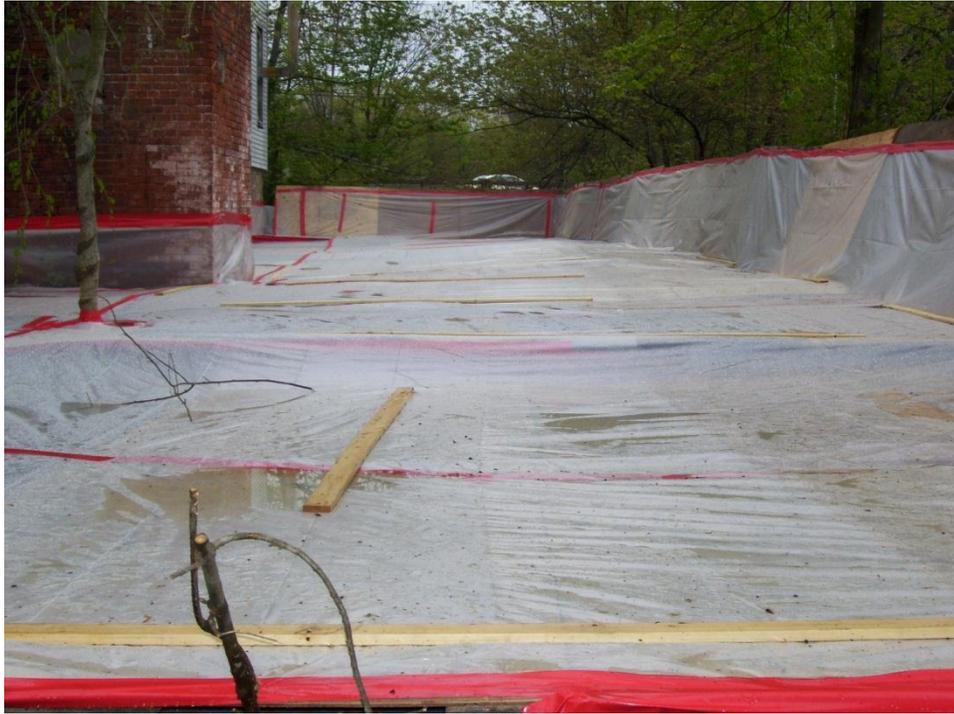
A scaffolding structure was used to prevent falling debris from impacting wetlands

- Erosion and sedimentation controls, as well as a scaffolding constructed as a debris shield, were constructed at the site in accordance with an *Order of Conditions* prepared in accordance with the *Massachusetts Wetlands Protection Act* (310 CMR 10.00).

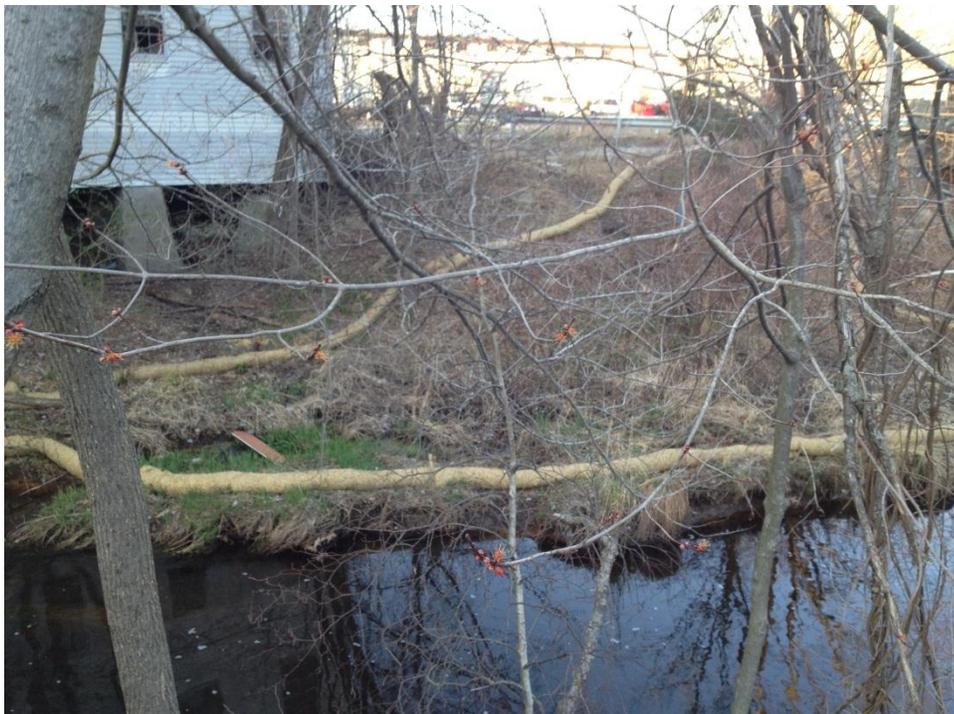
Erosion controls installed along Mine Brook

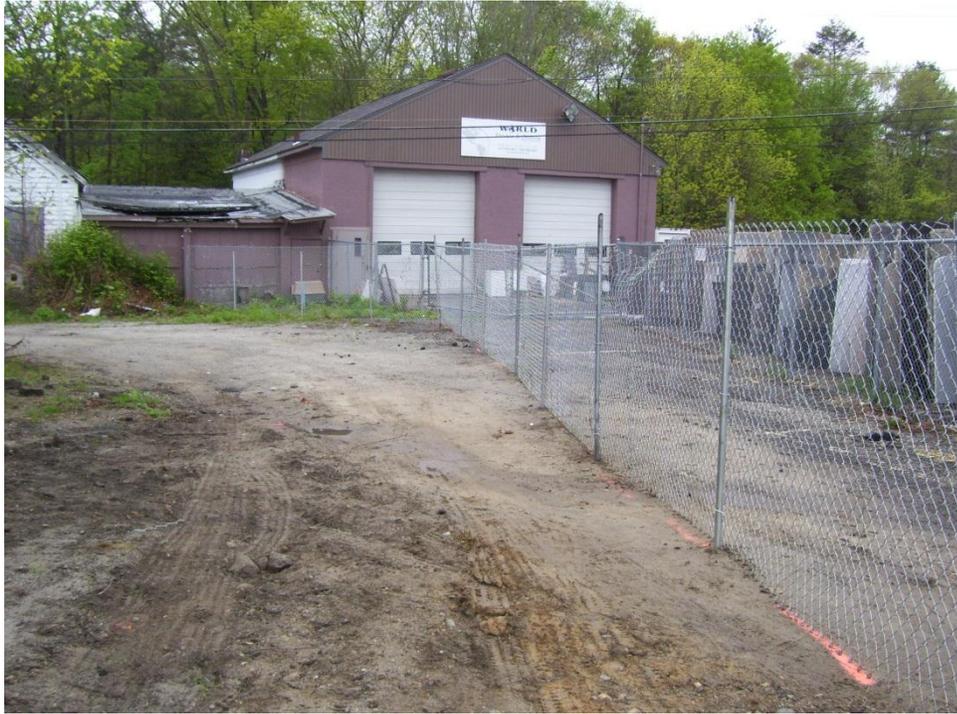
The property was fenced to prevent unauthorized access

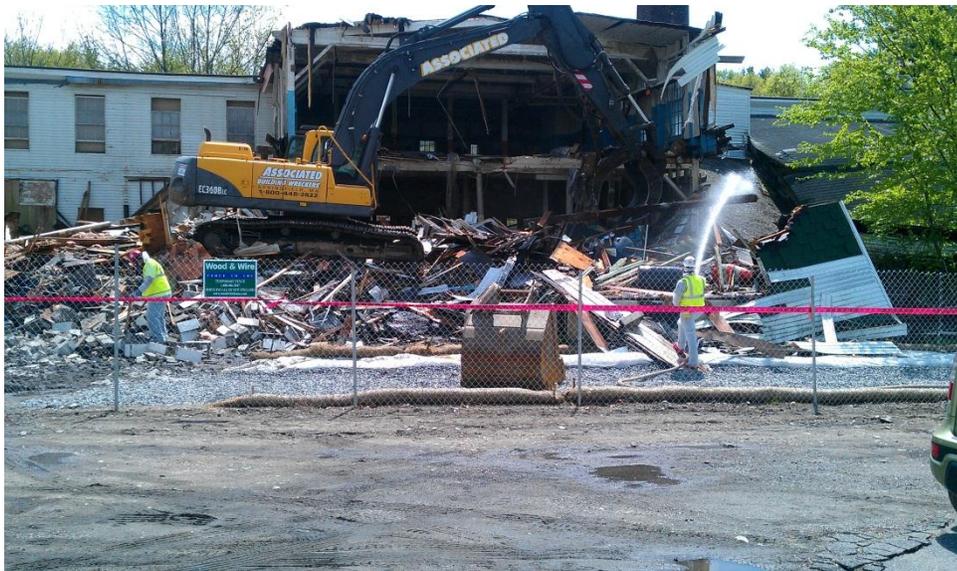
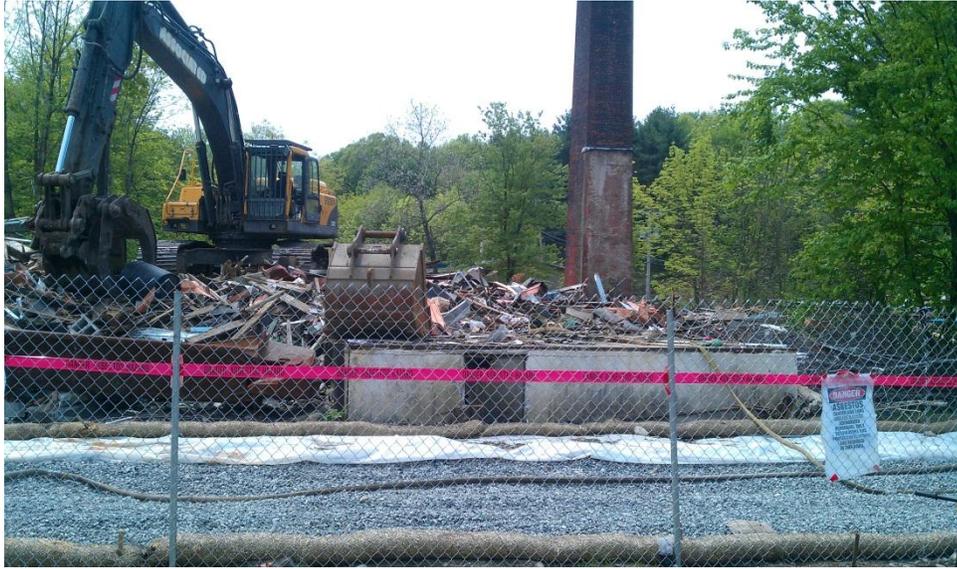
Building demolition

Building demolition (continued)

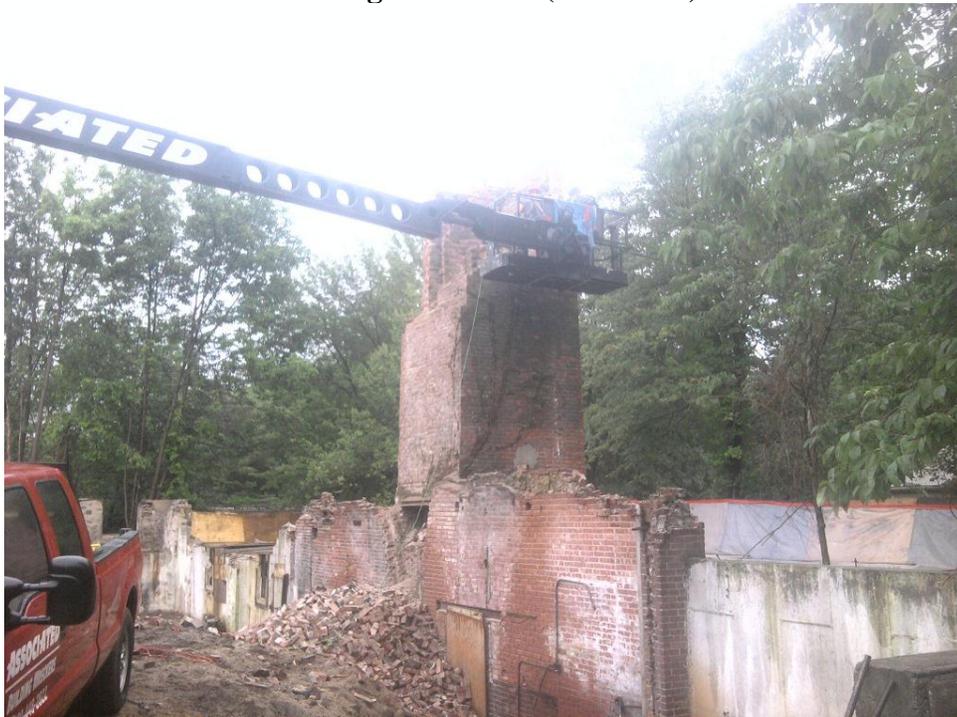
The chimney was demolished by hand and bricks were pulverized for fill

Following the completion of demolition activities and the concrete gravity wall construction, ABW crushed brick, concrete, and masonry rubble from the demolition activities to a maximum dimension of three inches. The rubble fill was used to partially backfill the foundation hole on the southern side of the site. The remainder of the foundation hole, as well as the raceway tunnel, was filled with sand and gravel provided by the Franklin Public Works department. The fill material was generated at off-site locations which were not impacted by releases of OHM which would degrade the site contrary to the anti-degradation provisions of the MCP (310 CMR 40.0032).

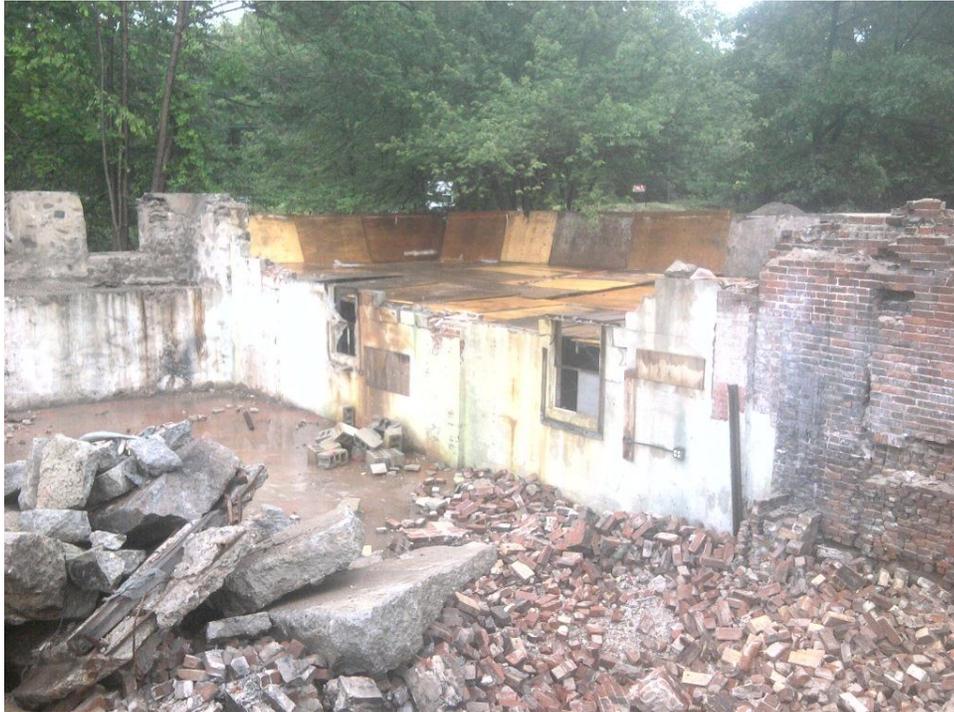
The scaffolding was dismantled after the overhead project work was completed

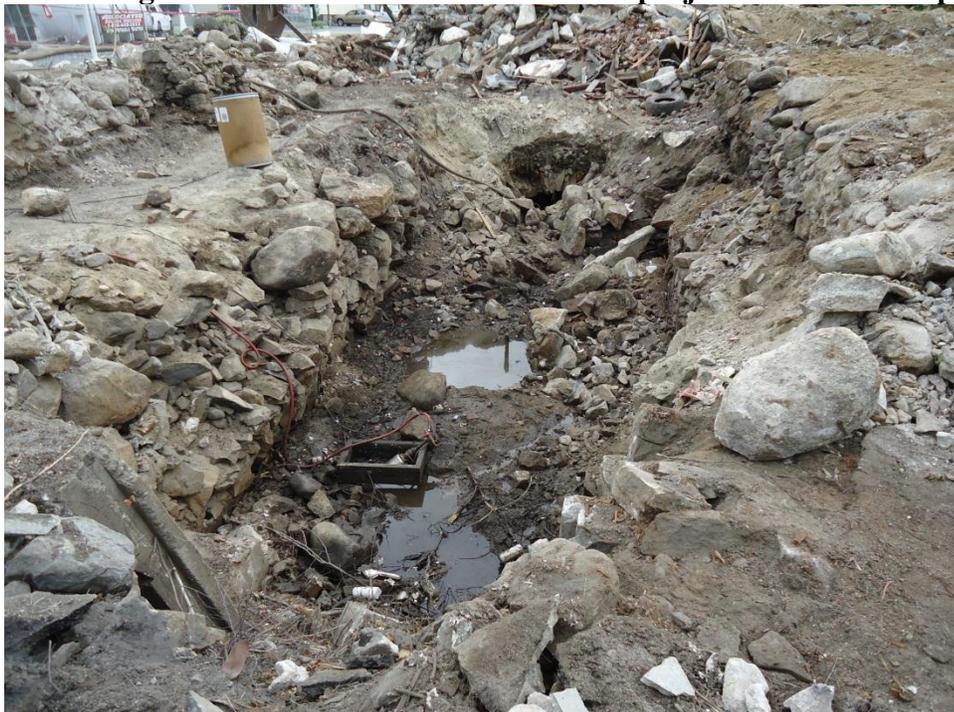
The raceway tunnel when initially exposed

The structure was observed to consist of a stone-walled channel with an arched roof, and a discharge control weir was located at the western end of the structure. Because the structure was lined in this way, it was considered a discrete volume of material and upon removal of the accessible sediment, no additional investigation was warranted during the RAM activities to evaluate potential releases from the raceway structure.

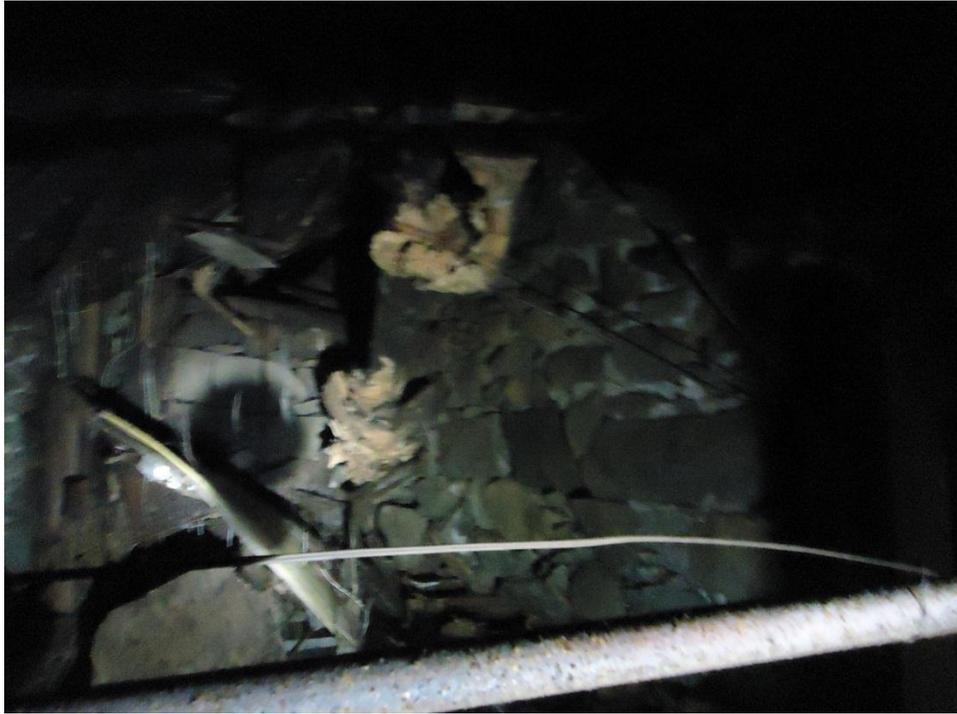
The raceway ended inside the basement of the Lot 22 building (bottom left)

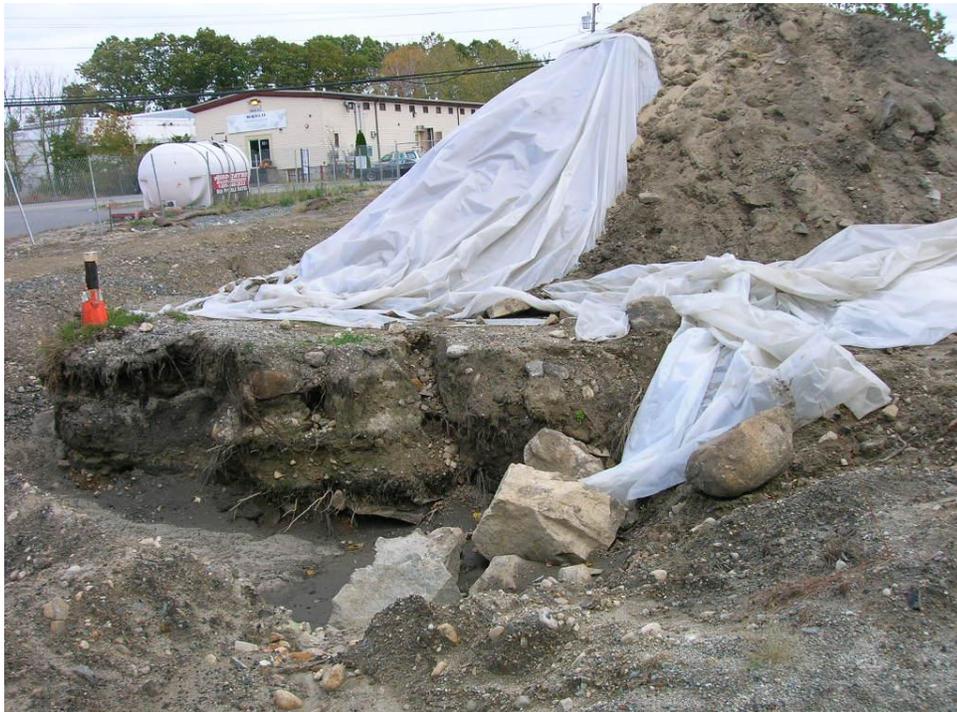
The excavation in the northwest corner of the site

Following the raceway excavation activities on August 20, 2012, ABW commenced excavation of the soil containing chlorinated VOC at the site. Excavation began along the northwestern corner of the former building foundation. Approximately 60 cubic yards of soil were excavated and stockpiled on-site on August 20, 2012. Excavation ceased due to the discovery of a previously unidentified sewer line, which was apparently connected to a neighboring business, and was damaged during excavation. Fuss & O'Neill collected eight soil samples at the limits of excavation for laboratory analysis. On September 18, 2012, ABW and Fuss & O'Neill continued excavation at the northwestern portion of the site, expanding the excavation area to the north and east based on analytical data which indicated that chlorinated VOC remained in soil in this area. Fuss & O'Neill collected four additional soil samples from the extents of the excavation. Additional excavation was conducted in this area on January 8, 2013, and one additional confirmatory sample was collected at that time. The soil sample locations are depicted on *Figure 2*.

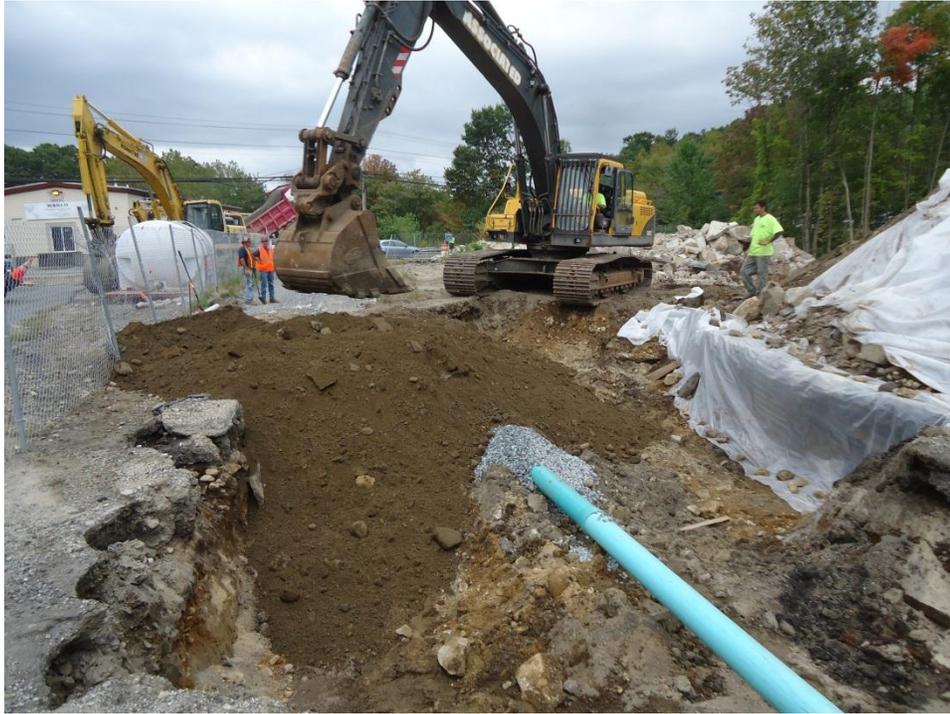
The repaired sewer line, which limited the excavation along the northern property line

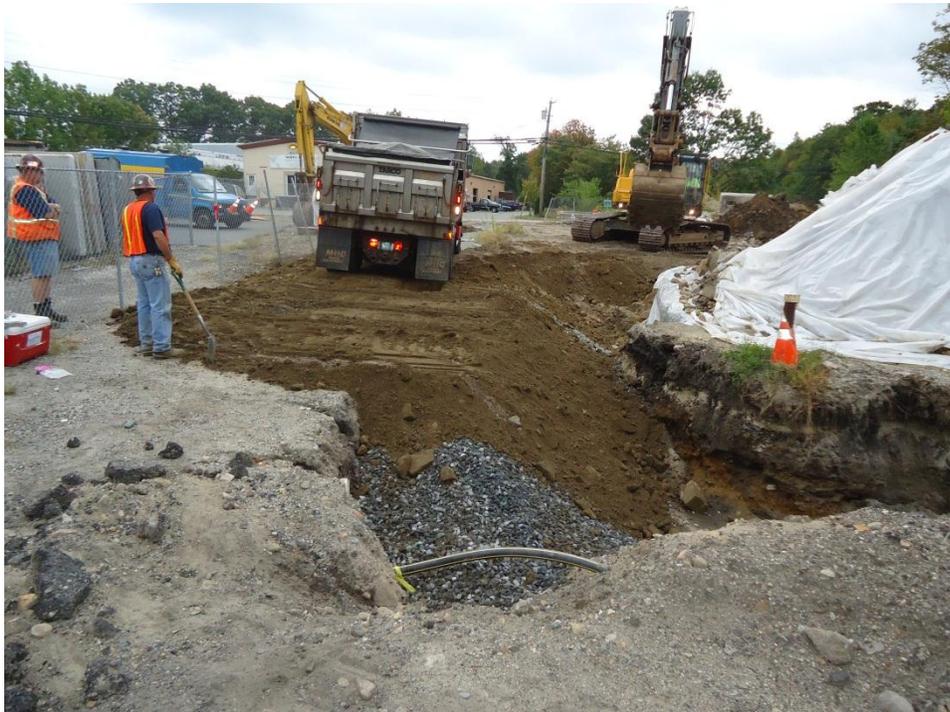
Backfilling the northwest excavation area

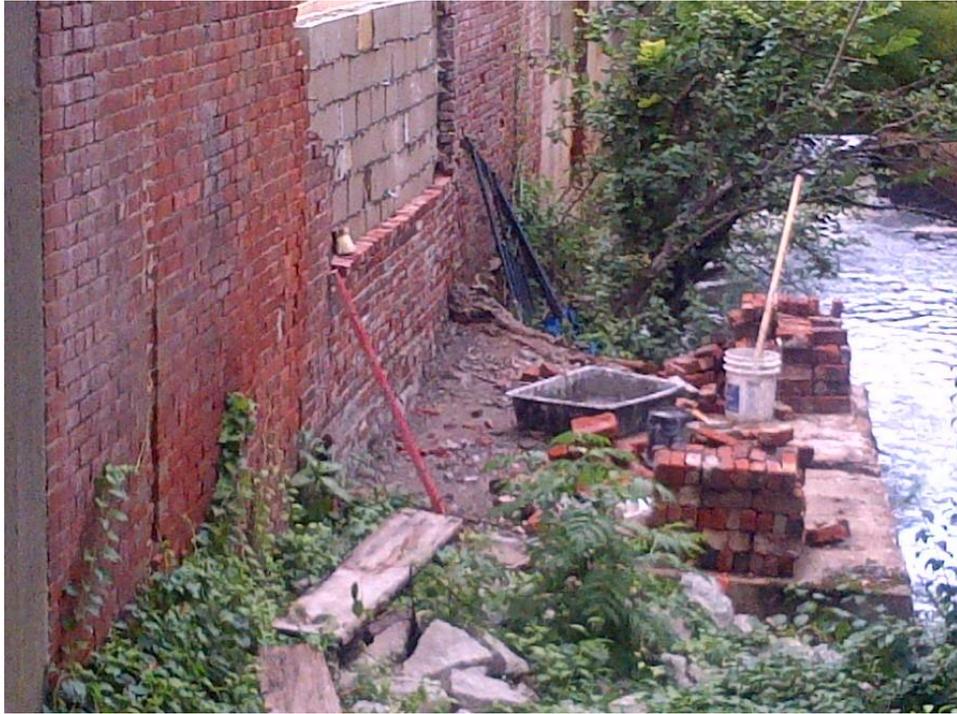
Restoration of the brick masonry wall façade

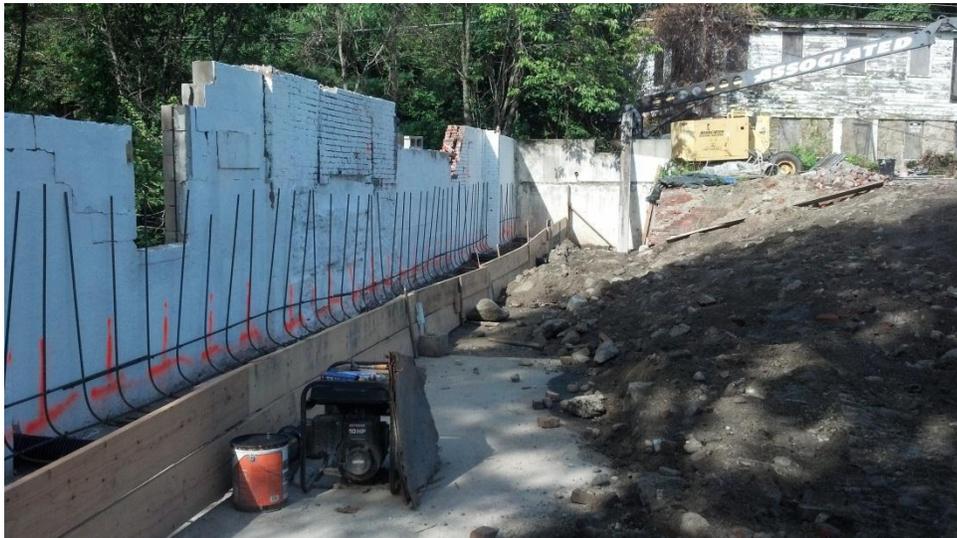
Installation of the concrete form work for the gravity wall

ABW and its subcontractors installed a steel-reinforced concrete gravity wall, as depicted on *Figure 2*, on the interior (northern) side of the former mill foundation wall. The gravity wall was installed in order to support the weight of soil at the site in order to restore the site to a generally level, stable grade which would not be subject to excessive erosion, and which would result in a generally level site for potential future redevelopment. The gravity wall was constructed of poured concrete in four lifts. The southern foundation wall was restored to a consistent elevation using brick and concrete masonry and completed with a two-inch thick poured concrete cap.

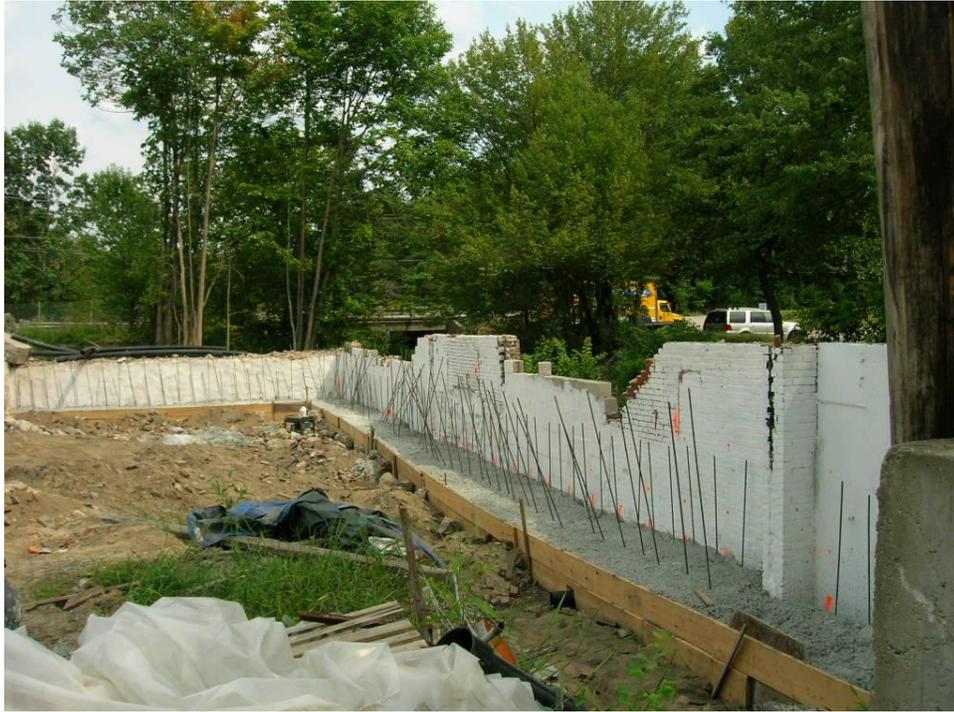
The cast-in-place concrete gravity wall behind the foundation façade

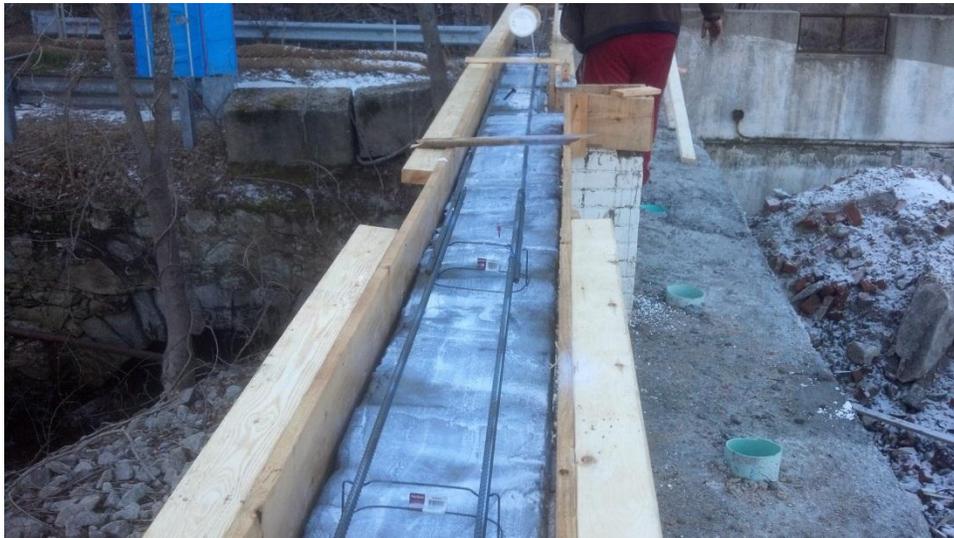
The foundation wall was capped with a poured concrete cap

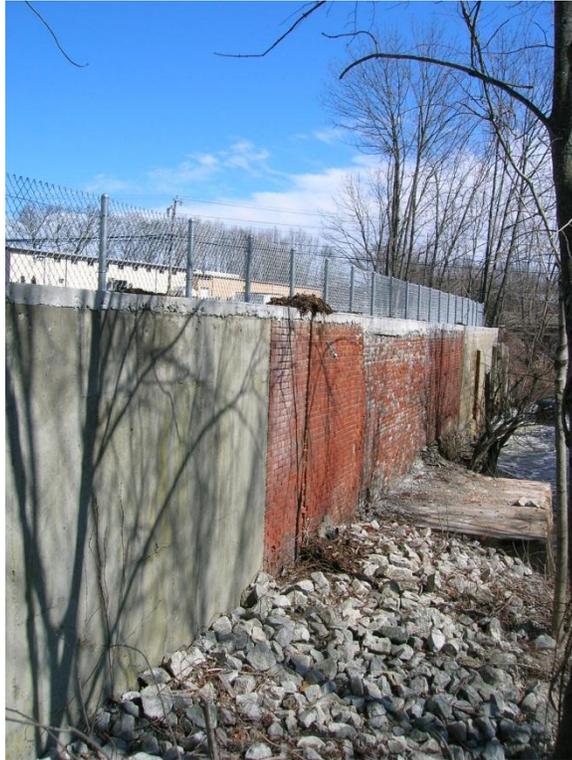
The finished exterior foundation wall and fence

site for potential future reuse. A permanent chain-link fence was constructed along the general alignment of these walls to mitigate the potential fall hazard associated with the wall height.
